HORIZONTAL MEMBER RE-PAIR

Engineering services and provision of manpower, equipment and consumables for the repair and rectification of damaged HM Jacket horizontal bracing for Heera Re-Development Phase III Project.

OFFSHORE & MARINE CASE HISTORY

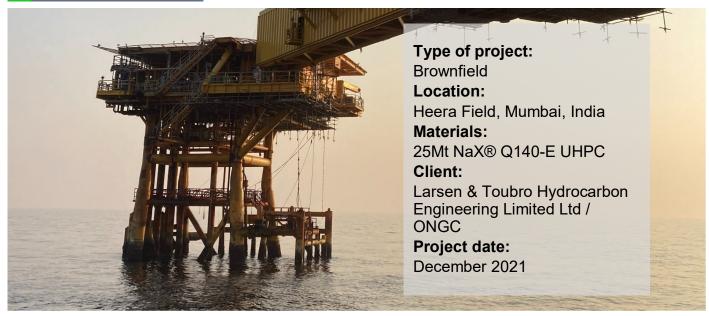
- The Member was broken and bent upward due to pulling impact
- The affected member was replaced with a new member using grouted clamp.

This was the first time a member was replaced by hinged grouted clamp technology at (-30.00) meter water depth, in Indian waters.
