Location:
Panna Mukta Field, PA3 Platform, India
Materials:
Nax® Q140 UHPC Grout
Client:
Shell India
(formerly BG Exploration & Production India Ltd.)
Project date:
March – April 2017 (11 days)

REPAIR OF CONDUCTOR CASINGS USING ENGINEERED GROUTED CLAMPS

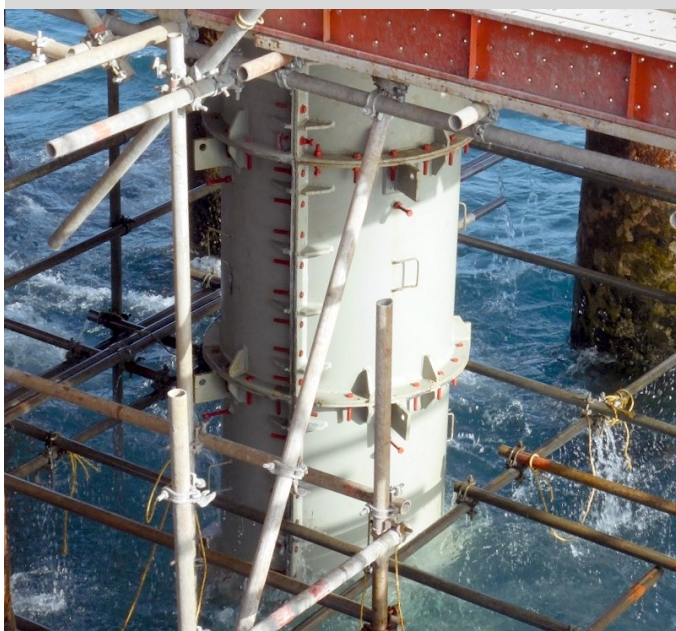
It was observed that the PA platform had a parted conductor casing, exposing the internal casings. Nautech was awarded the job to carry out structural integrity analysis; develop a repair methodology to reinstate the damaged section and structural integrity of the conductor.

- Pre-Engineering Survey of the damaged conductor casing
- Carry out Engineering Design & Analysis
- Carry out design of External Grouted Clamp
- Fabrication & Installation of External Grouted clamp
- Alignment of the damaged casing & Installation of clamp offshore
- Grouting of the annulus between the clamp & conductor casing
- Post installation survey & final documentation
